TECHNICAL REPORT

# THE GLACIAL LAKE HANDBOOK

REDUCING RISK FROM DANGEROUS GLACIAL LAKES IN THE  
CORDILLERA BLANCA, PERU

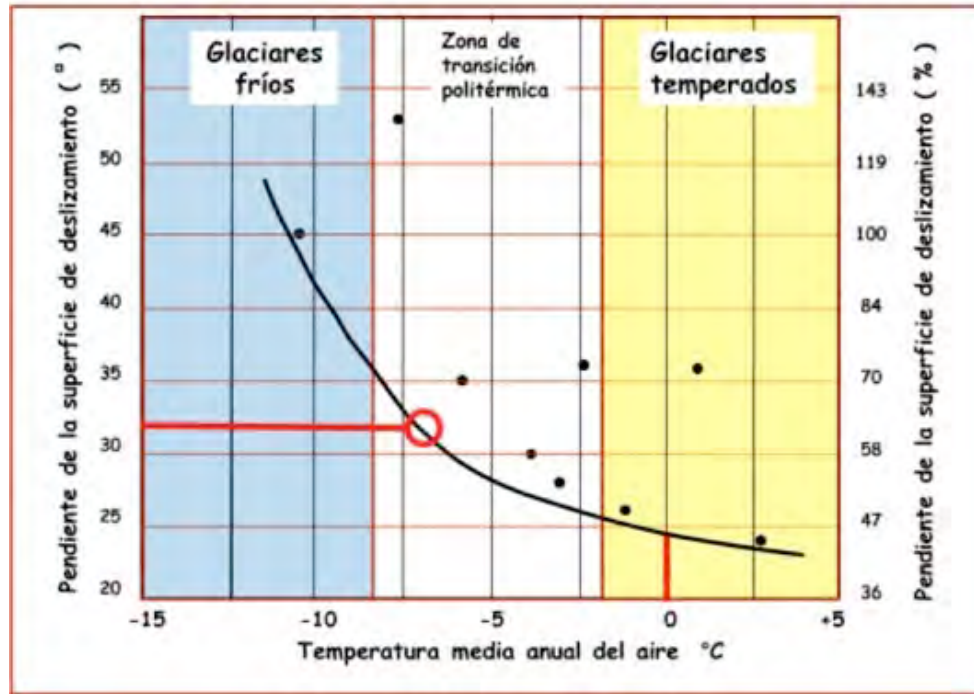
**Figure 3-1 Critical Slopes for Different Types of Tropical and High Latitude Glaciers.** Vertical axis: Slippage surface gradient. Three categories: cold glaciers, polythermal transition zone, temperate glaciers. Horizontal axis: Average annual air temperature. Source: Institute of Geography of the University of Zurich

Slope is an important factor in determining the potential of avalanche debris falling into glacial lakes. The slope is used in calculating glacier stability and the probability of failure from edge effects or ramp type. Scientists at the University of Zurich have developed empirical relationships based on glacier studies in the Alps that help to determine the slope at which slippage might occur depending on temperature. This relationship allows slope measurements from satellite imagery and digital elevation models to be used in determining the potential of a flood event. For example, a 25-degree gradient might lead to sliding of warm glaciers in Peru, whereas the same gradient might not lead to sliding in the cold environments of high-latitude glaciers. Adhesion of the ice to underlying bedrock is highly dependent on ambient air temperature. Good examples include [Case Study 5.1: Lake Palcacocha](#) and [Case Study 5.3: Lake 513](#), both of which have bedrock slopes steeper than 30 degrees.

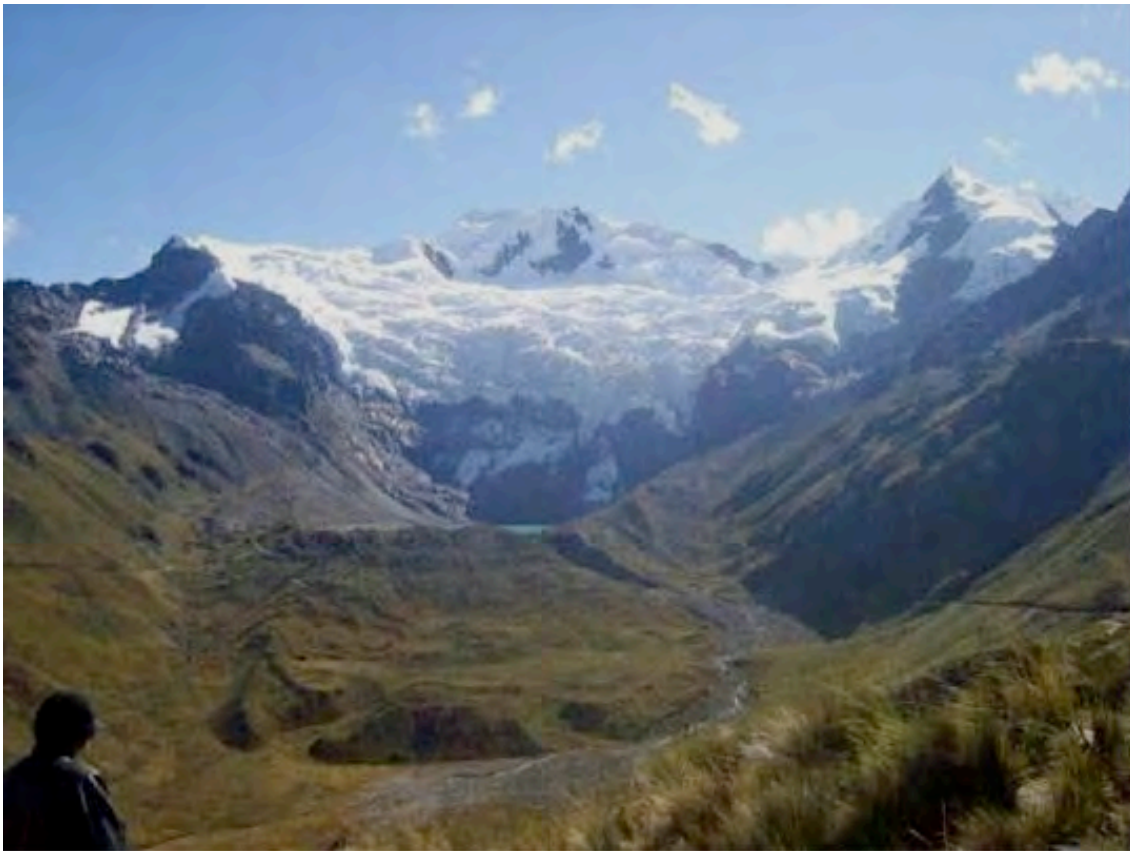
Large hanging glacier over Lazo Huntay Lake in the Cordillera Huaytapallana, in central Peru, 1990. Photo: César Portocarrero

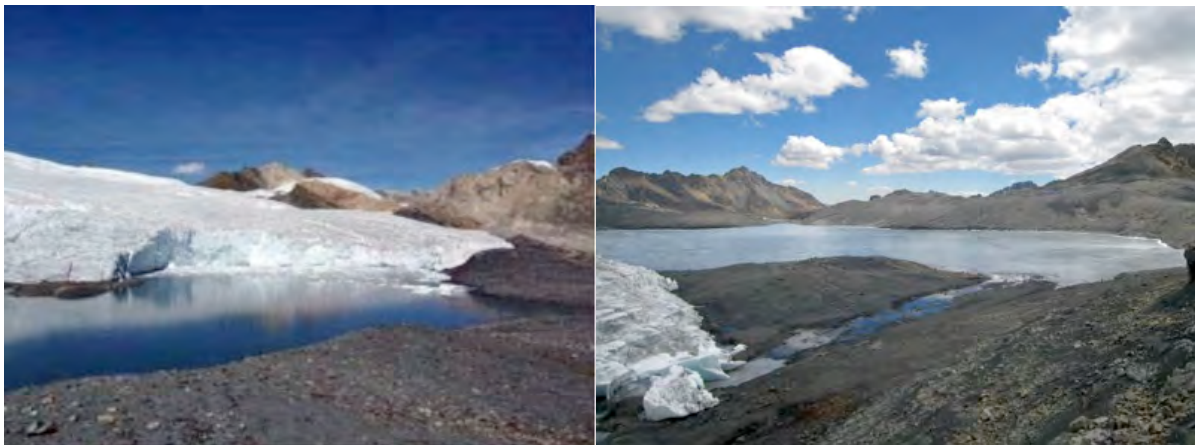
**Pastoruri Glacier, Peru, in contact with an emerging lake, showing the calving process.** Photos: César Portocarrero (left), Daene McKinney (right)

As glaciers retreat, it often leaves behind empty spaces that are gradually filled with meltwater and eventually form lakes. As these lakes are still in direct contact with the glacier tongue, the temperature difference between the water and the glacier produces an eroding effect that eventually causes the ice to break off and cascade into the lake. This can create a dangerous surge wave, depending on the mass of the ice and the volume and shape of the lake. This phenomenon has caused natural disasters in many places. Examples include the event in [Case Study 5.1: Palcacocha Lake](#), which flooded the city of Huaraz. Also in [Case Study 5.16: Lazo Huntay Lake](#), which flooded the town of Huancayo, and, more recently, in an unnamed lake at the foot of the Nevado Chicón (see [Case Study 5.17: Riticocha Lake](#)).

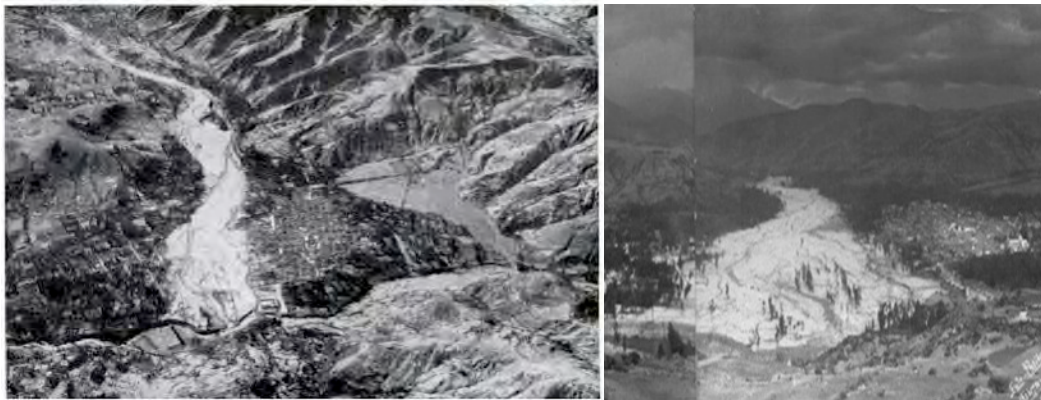
**The GLOF's destructive path through the city of Huaraz in 1941. Servicio Aerofotográfico Nacional del Perú**

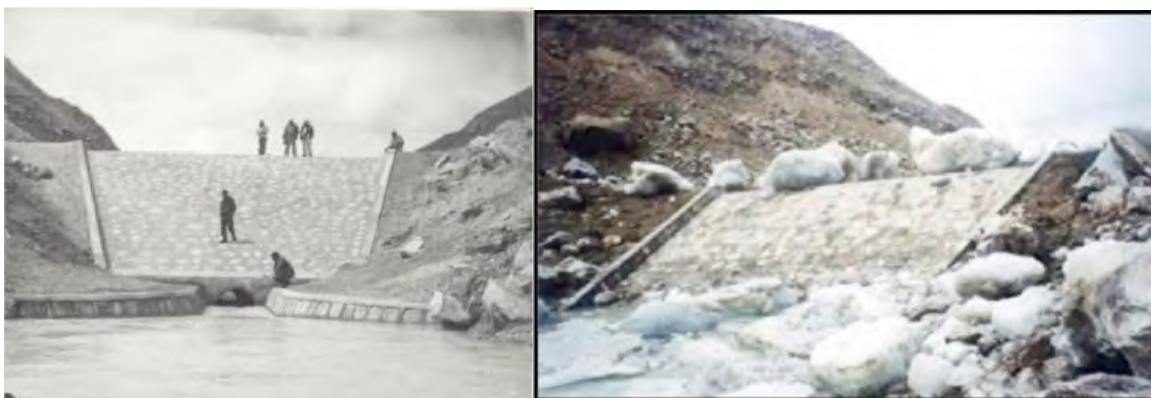
**The safety dam on Palcacocha Lake as construction was being completed in 1974 (left) and with ice debris following the 2003 landslide that launched a flood that was mostly contained by the dam. Left photo: César Portocarrero. Right: Glaciology Unit Office Archives**

In an effort to mitigate the risk of the lake, two 36 inches (915 millimeters) steel pipes were placed in the notch that had been cut into the moraine by the GLOF. Then, an 8-meter rammed earth dam was built over the top. These safety works continued working properly until the May 31, 1970, earthquake (magnitude 7.9) destroyed the dam's foundations, breaking the drainpipes installed underneath.

At that time the Lakes Safety and Glaciology Unit decided to lower the lake's level by one meter, which they concluded was enough based on its low volume of 500,000 m<sup>3</sup>. In 1974, they installed a 48 inches (1,219 millimeters) diameter steel pipe capped by a new, tightly compacted dirt dam 8 meters high. They also strengthened the right side of the moraine outflow to reduce erosion from outbursts. This provided a freeboard of 8 meters in the lake as a buffer against future surge waves.

Nineteen years later, in March 2003, the moraine along the lake's left flank slipped, launching a violent diagonal wave that traversed the lake and heavily eroded the reinforced dam. Photographs, taken five days after the 2003 event, show chunks of ice still sitting on the 8-meter dam, and water levels still 4 meters above its normal level. This event frightened the Huaraz city authorities. The regional government quickly repaired the damaged structures.

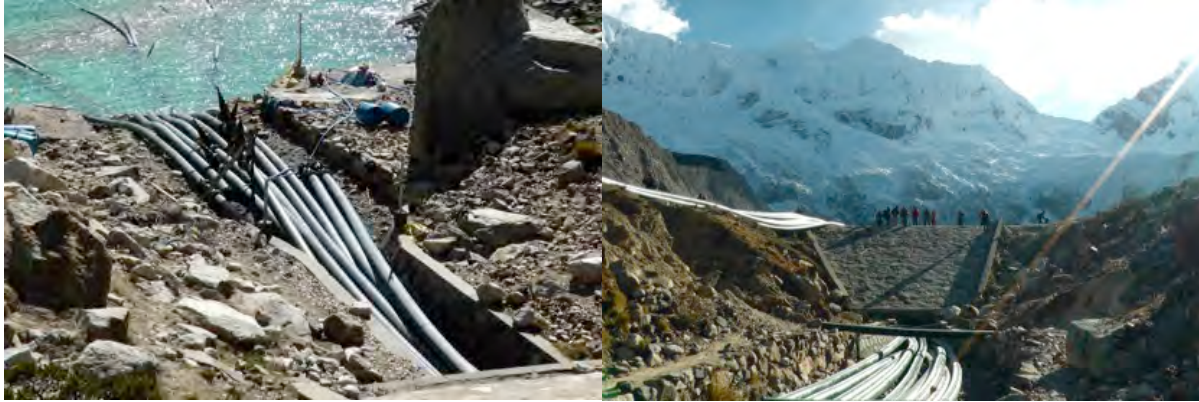
**Palcacocha Lake in 2013 showing the siphon pipes entering (left) and exiting the tunnel under the dam. Photos: John Harlin**

The Glaciology and Water Resources Unit prepared a plan in 2010 to lower the water level of Palcacocha Lake by an additional 15 meters. The cost estimate for this work came in at US\$4 million. Later in 2010, Peru's National Water Authority unexpectedly relieved the Glaciology and Water Resources Unit from responsibility for glacial lakes and turned the lake-lowering plan over to the regional government in Ancash. Ancash officials did not think they could authorize these funds quickly, so they searched for an interim, cheaper way to reduce risk from the lake. They decided to use six 10-inch (254 millimeters)-diameter pipes about 700 meters long to siphon off approximately 7 million cubic meters of water. Two years later (in 2011), the siphons started draining the lake though at a slower rate than planned due to design defects. As of July 2013, the water level had been lowered approximately 3 meters, roughly half the amount needed before the drainage ditch can be started.

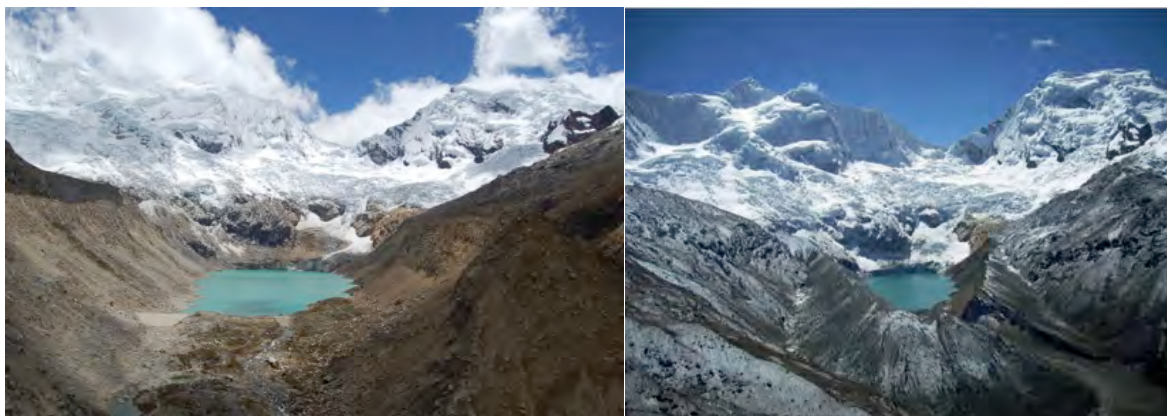
**Left: Palcacocha Lake in 2013 taken from the top of the moraine. The two safety dams can be seen. The dam on the right contains the drainage pipes. Photo: César Portocarrero. Right: Palcacocha Lake in 2008 showing its enclosing moraine; the 1941 breach is visible in the lower right. Photo: Colette Simonds**

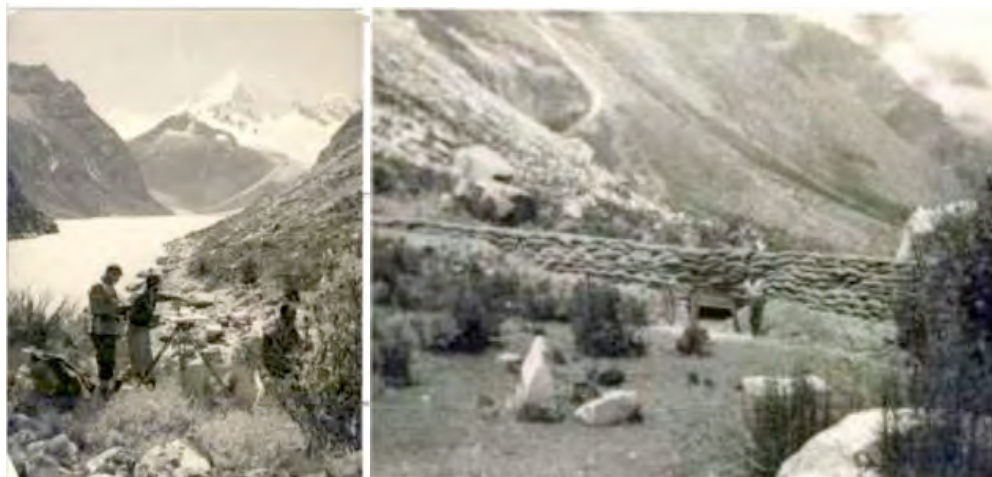
**1951 photos of surveyors and a sand bag dam built as a temporary barrier below Lake Parón. Photos: Glaciology Unit Office Archives**

Some safety measures were implemented after the 1951 outburst floods from Lake Artesoncocha including placing sand bags over the natural dam. Topographical studies examined lake characteristics for future drainage projects.

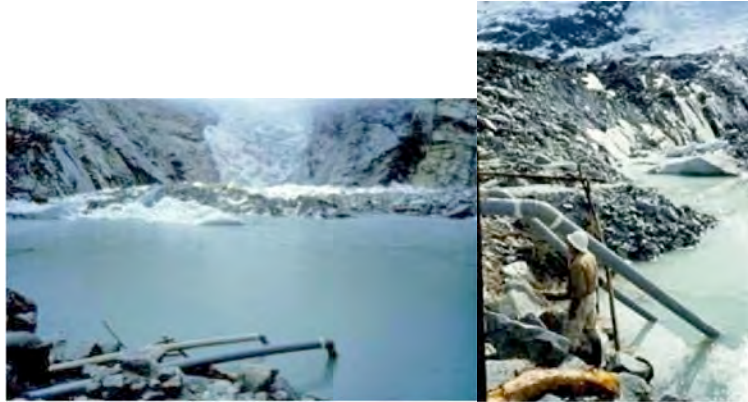
The initial siphoning process to lower the water level of Lake 513 in the late 1980s. Siphoning was an interim measure until funding was received for construction of the tunnel. Photos: César Portocarrero

The remoteness of the area and the lack of resources available for a major project led the Glaciology Unit to install temporary siphons in 1989 (with financial support from the British and Austrian governments). These plastic pipes, 10 inches (254 millimeters) and 12 inches (305 millimeters) in diameter, were used to lower the water level by about 6 meters. In 1992, drilling started for a tunnel that would lower the water level by 20 meters. The work was financed by the Peru's Civil Defense Institute.

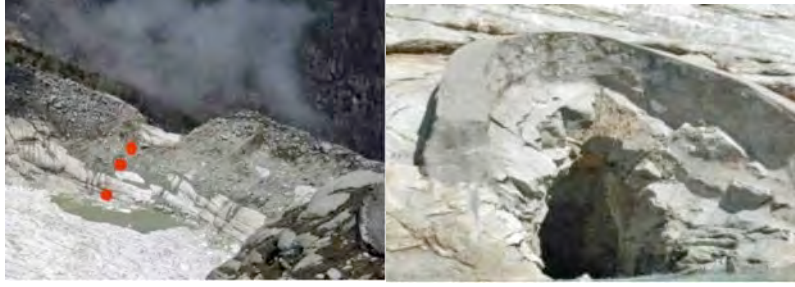
**Red dots mark the tunnel entrances on Lake 513. The photo on the right shows the lowest entrance. Photos: César Portocarrero**

The original plan was for the tunnel to contact the lake at a depth of 20 meters, using underwater blasting and placing devices inside the tunnel to regulate the outflow. However, this plan was abandoned during construction when the driller became afraid to blast the connection to the lake at such a depth. Instead, a sloping shaft was built from which connections would be added at increasing depths of 5, 10, 15, and 20 meters.

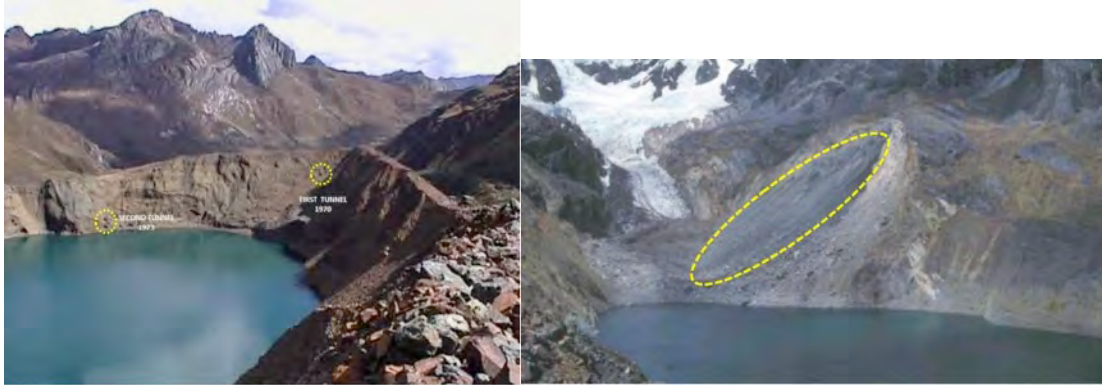
**Safuna Alta Lake.** Left: Locations of the two tunnels drilled into the moraine in the early 1970s as the lake's level dropped on its own. Right: The source of the landslide in 2002 that launched a wave at least 80 meters in height. Photos: César Portocarrero (1974)

**History of work:** In the early 1960s the Glaciology Unit recommended building a 47-meter-long drainage tunnel that would prevent the lake's water level from rising above 4,360 meters. In April 1970, a tunnel was completed that was supposed to reduce the water level by 38 meters (Ames and Francou, 1995). However, by then the water level had dropped by 30 meters, so that the tunnel was above the lake's new water level. A month later, a large earthquake severely damaged the tunnel. A new 159-meter-long tunnel was built that, like the previous tunnel, had to be excavated through morainic material. (Report of the Glaciology and Lake Control Office of the Corporation Peruana del Santa, 1972).

In 2002, a rockslide created a wave of at least 80 meters in height (Reynolds, 2003). The wave damaged both tunnels, but did not destroy the moraine.

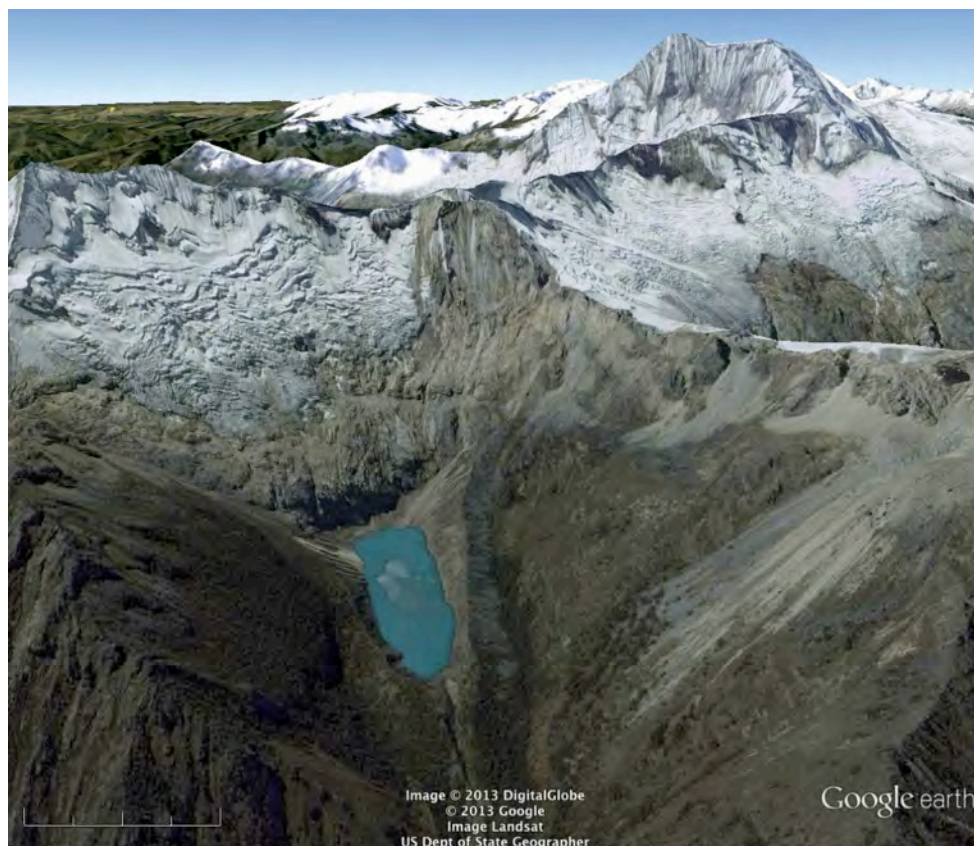
Huallecacocha Lake with its safety dam visible lower right.

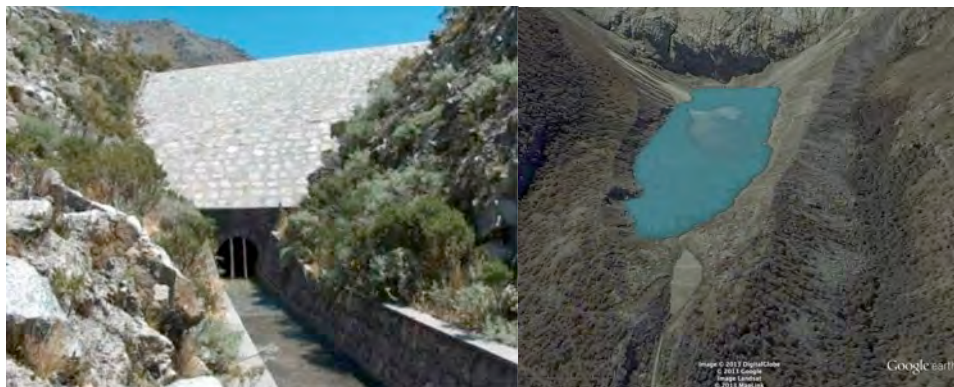
**Huallecacocha's completed safety dam from below (1978) and above (2013). Photo: César Portocarrero**

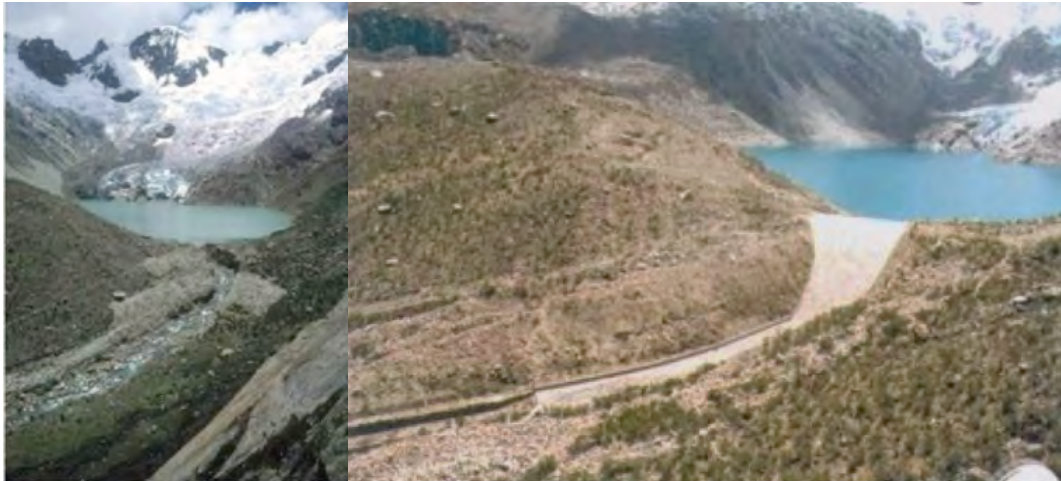
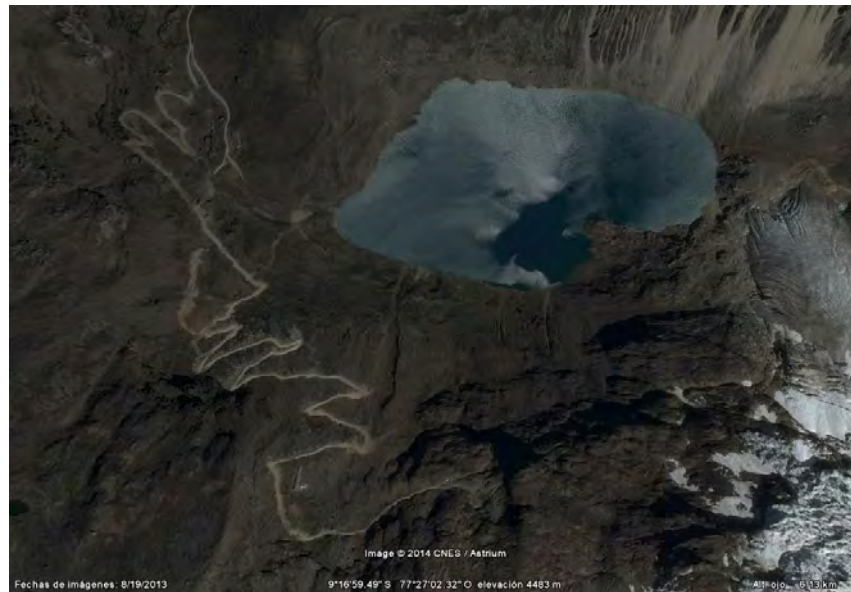
**Paccharruri Lake showing the sluice cut to lower the water level (left) and the completed safety dam and outflow canal beyond the covered sluice. Photos: César Portocarrero**

Work began in the early 1980s to lower the level of the water surface by 10 meters. A covered sluice 71 meters long and 1.8 meters in diameter was built, over which an 18-meter-high safety dam was added. As in other works of the same type, covered access and exit conduits were built to prevent erosion of the moraine material and safely move water downstream.

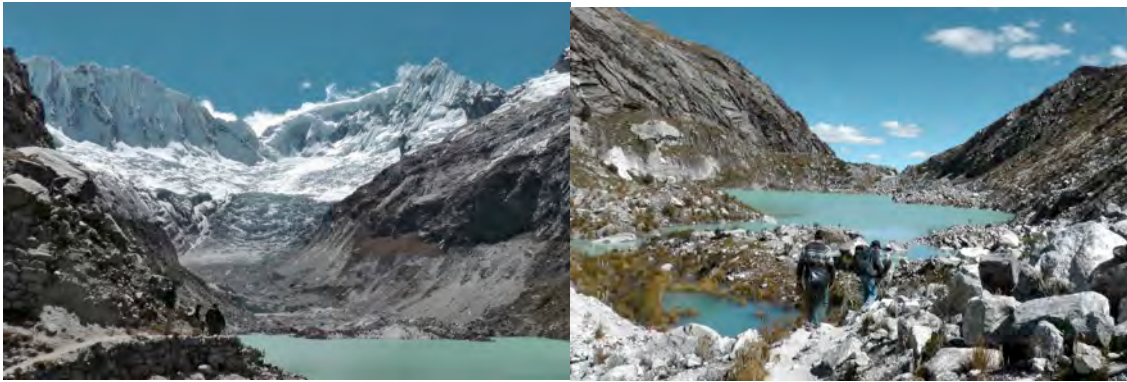
**Left: Looking upstream from the safety dam at Llaca Lake. Right: The view downstream across Llaca Lake. Photos: John Harlin**

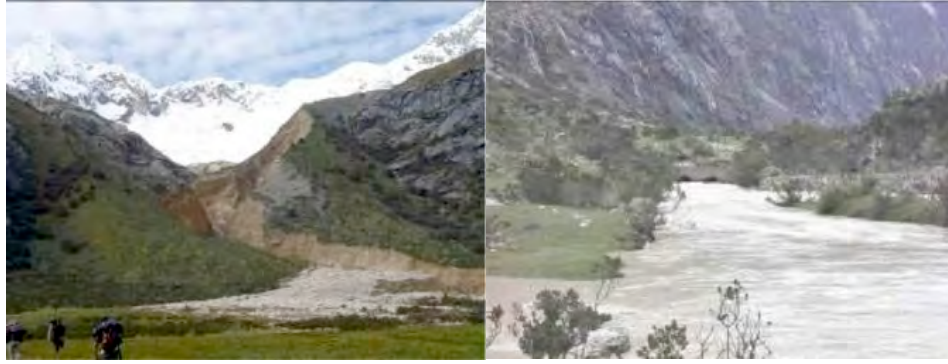
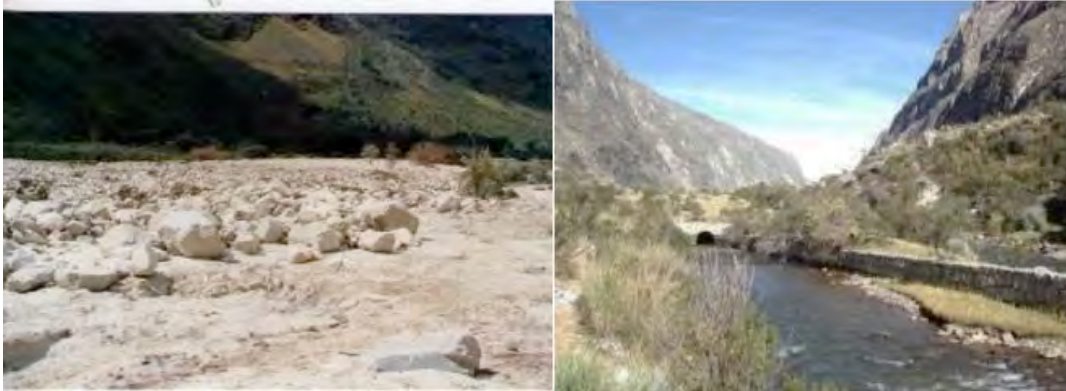
**Top left: The path cut through Artizon Lake's moraine during its 2012 GLOF. Top right: Floodwaters resulting from Artizon's GLOF almost filled the drain pipes under Jatuncocha's dam. Bottom left: Debris from the 2012 Artizon GLOF. Bottom right: Relatively normal flows through the Jatuncocha tunnels. Photos: César Portocarrero**

Although the Jatuncocha dam contained the flood, the flow through the two pipes reached more than 10 cubic meters per second down the steep valley below, causing substantial erosion and destruction of homes, property, and roads.

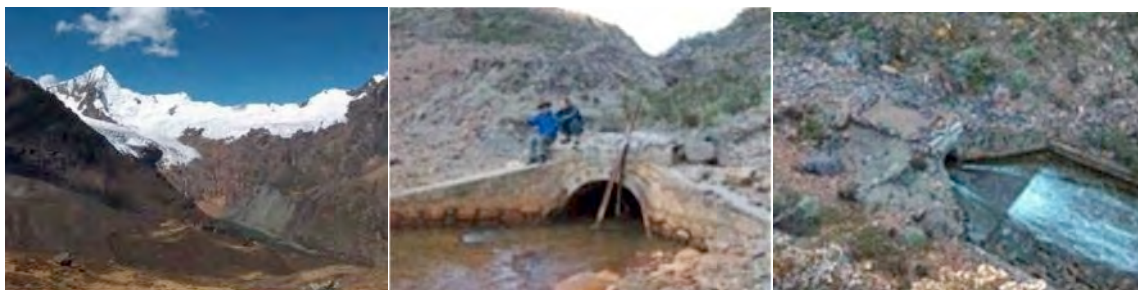
**Tullparraju Lake showing its steep flanks and the hanging glacier above. Middle and right photos show the entrance and exit of the drainage tunnel. All photos from 1974: César Portocarrero**

Over the years the tunnel developed numerous leaks, which prompted the Glaciology Unit to strengthen the drainage tunnel with concrete in 1974. The Unit also built a reinforced 10-meter-high earth dam above the tunnel to counteract possible glacier wave surges caused by avalanches or landslides.

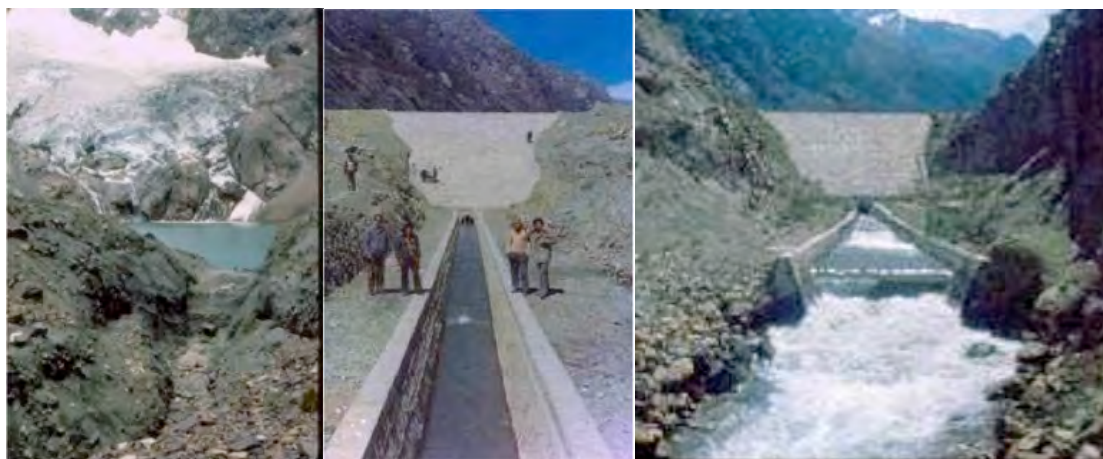
**Constructing the Shallap Lake safety dam and water channel in 1973 and the completed work in 1974. Photos: César Portocarrero**

holding 4.7 million m<sup>3</sup> of water. The natural dam consisted of two high lateral moraines and a lower terminal moraine where the 4-meter-high dam had been built. In 1972–1974 the Glaciology Unit lowered the water surface by 10 meters and built an 80-meter-long covered passage, including a steel pipe beneath an earth dam and masonry channels. As in other cases, the artificial dam was built with a waterproof core and masonry walls.

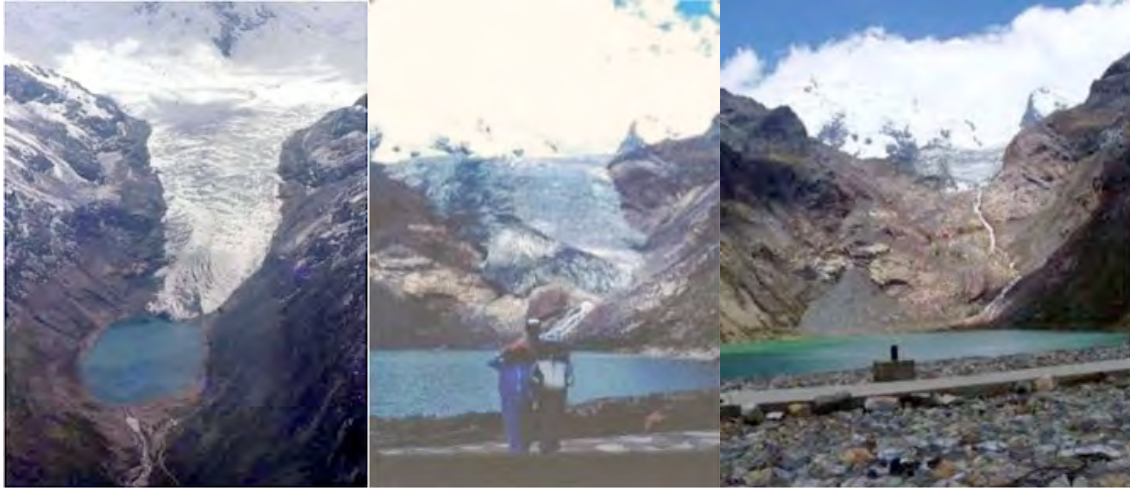
The retreating glacial tongue above Shallap Lake in 1974, 1980, and 2010. Photos: César Portocarrero

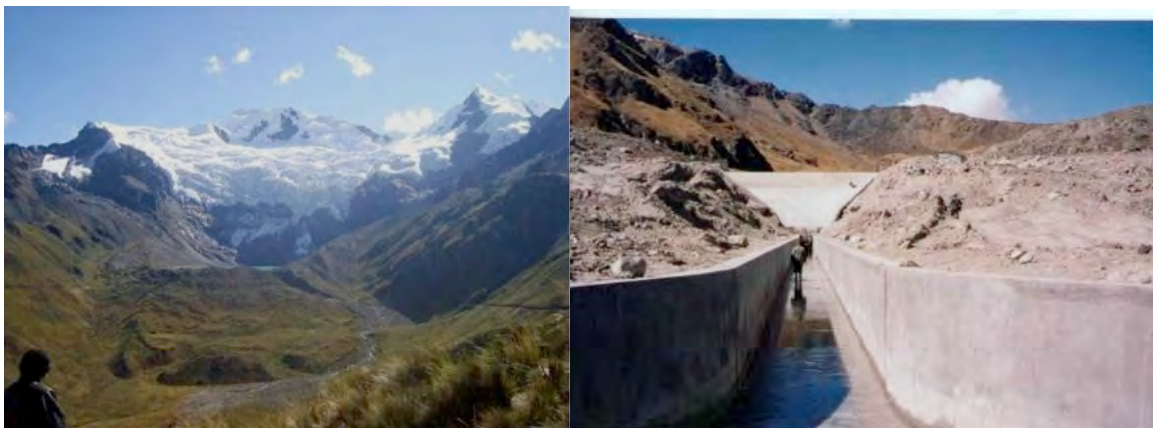
**Lazo Huntay Lake showing the still-massive hanging glacier in 1990, and the newly completed safety works in 1990. Photos: César Portocarrero**

In 1977, the Glaciology Unit initiated work (with support from The National Institute of Civil Defense of Peru) to partially drain the lake. Then, in early 1990, the Glaciology Unit recommenced work to complete the project by further lowering the water level, building an exhaust duct, and installing a dam.

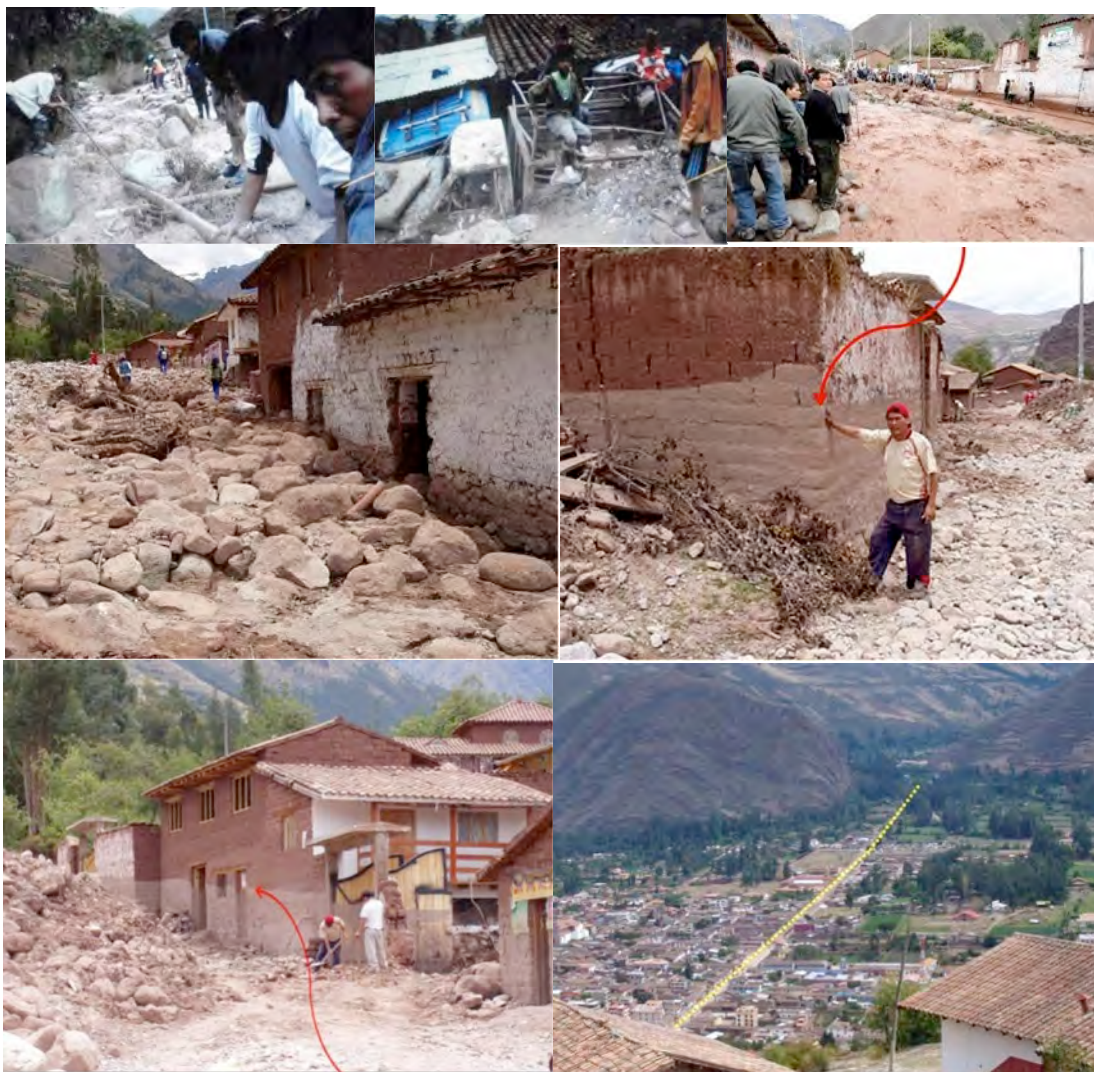
**Top row: Photos from the flood of the Chicón River in San Isidro and Urubamba resulting from the Riticocha GLOF on 17 October 2010. Middle row: Debris and flood lines on walls in Urubamba in 2010. Lower right: The path the Chicón River took through Urubamba in 2010. Top row photos: Municipality of Urubamba. Other photos: César Portocarrero**

On October 17, 2010, a large flash flood of the Chicón River damaged small towns as the water descended to the city of Urubamba. Investigations revealed that the flash flood was a GLOF from a new lake that had appeared at the foot of the Chicón Glacier: Riticocha Lake. Videos taken from helicopters revealed blocky fragments of ice on rock walls near the lake, indicating that one or more large waves had deposited them. It appeared that an original mass of water had triggered a second, lower lake to also be partially emptied.

Such heavy destruction leads scientists from the Cusco Civil Defense to believe that the volume of the GLOF was larger than the volume of the present lake. Clues include the magnitude and size of transported rocks, the volume of debris, and the boulders that reached the town of Urubamba. The floodwater's destructive power was increased by recent road building activities. Construction had loosened the earth and construction debris, including broken tree trunks, had been dumped into the riverbed.

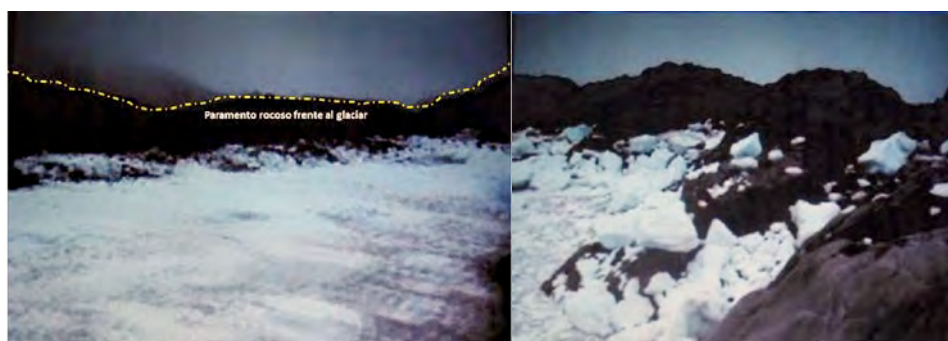
**Waves deposited these large ice fragments high on Riticocha's rock walls. These photographs were taken a few days after the event and were taken during daylight, but are dark because it was captured from video. The dashed yellow line indicates the edge of the glacier. Photos: Urubamba Civil Defense**
